**Re: Ameren Missouri  
Sioux Power Station  
Response to Dewberry & Davis Draft Coal Combustion Waste Impoundments  
Round 7 – Dam Assessment Report**

RE: Ash Pond Dam Stability Analysis  
Sioux Power Station

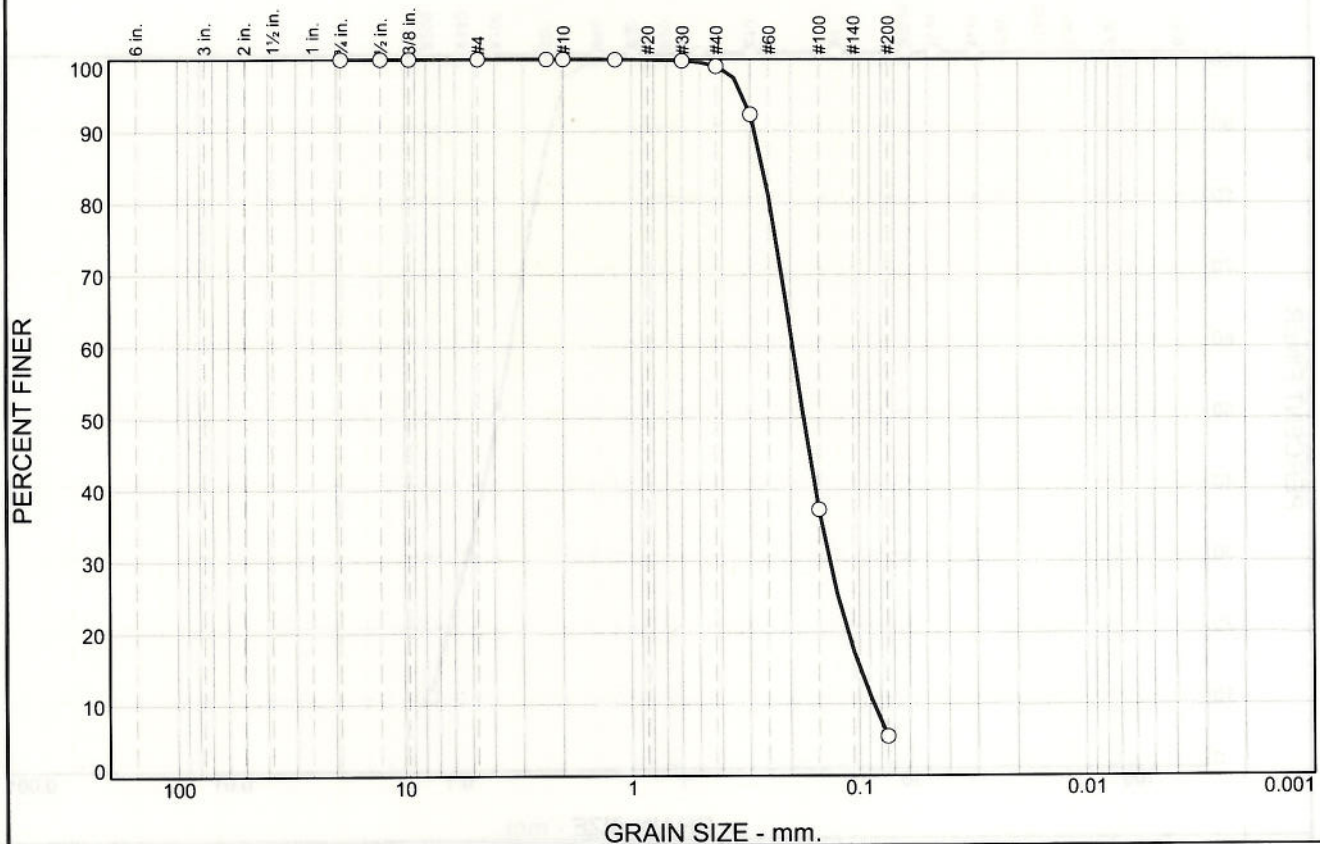
The seepage area with concentrated flow was observed making sediment and a sample of the sediment yielded was obtained. The grain size of the sediment was quantified and is provided in Figures 2-7 to 2-10. A sandbag ring was constructed around the area with concentrated flow to provide estimates of flow rate, qualitatively estimate the sediment yield and slow the transport of sediment. The flow rate was measured with a 90° v-notched weir at 3 stages of the sandbag construction, or three different ponding levels above the seep. The bottom ash pond level was at approximately elevation 434 feet (roughly 1 to 2 feet lower than normal because of a plant outage) or 15 feet the elevation of the seep. The flow measurements are approximate due to seepage through and under the sandbags, but are a reasonable

Observations of the seep show that the sediment yield is intermittent. The history of the seepage area is unknown. We recommend constructing an inverted filter over the bank of the seepage area to help stop the migration of fines from within the embankment. The details of the filter are presented in Appendix C. The filter should generally consist of a two foot thick base layer of coarse sand above the existing ground surface. The coarse sand should be overlain with a two foot intermediate layer consisting of gravel. Four feet of rip rap is recommended at the surface of the filter to protect against wave and current erosion. The recommended gradations for the coarse sand, and gravel and rip rap are presented in Appendix C. A sketch of the approximate location, limits of the filter and a typical cross-section of the filter are also presented in this appendix.

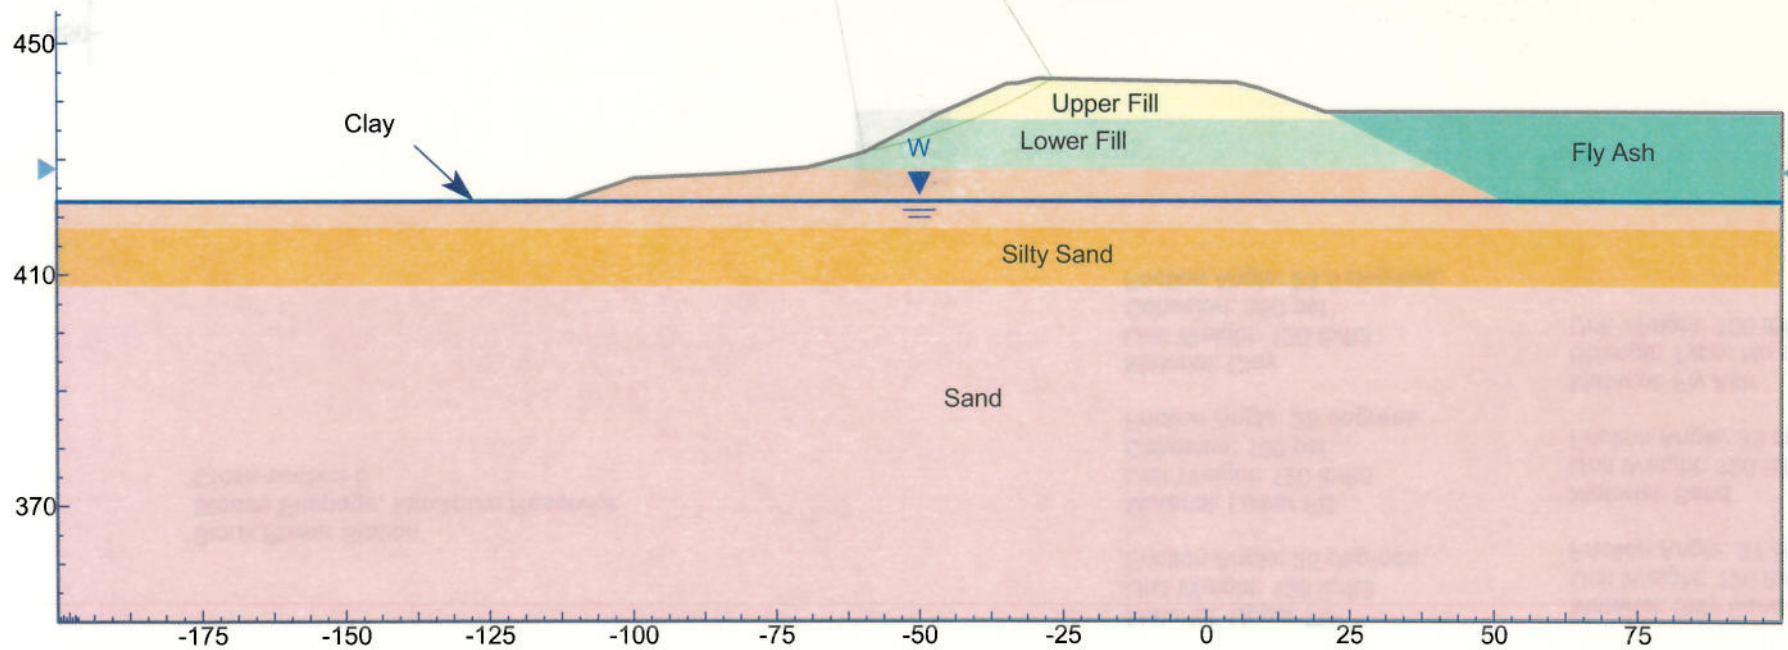
Sioux Power Station  
Steady Seepage, Maximum Reservoir  
Cross-section 5

Material: Upper Fill  
Unit Weight: 120 lb/ft<sup>3</sup>  
Friction Angle: 25 degrees

Material: Clay  
Unit Weight: 120 lb/ft<sup>3</sup>  
Cohesion: 350 psf  
Friction Angle: 23.5 degrees

Material: Fly Ash  
Strength Type: No strength  
Unit Weight: 100 lb/ft<sup>3</sup>

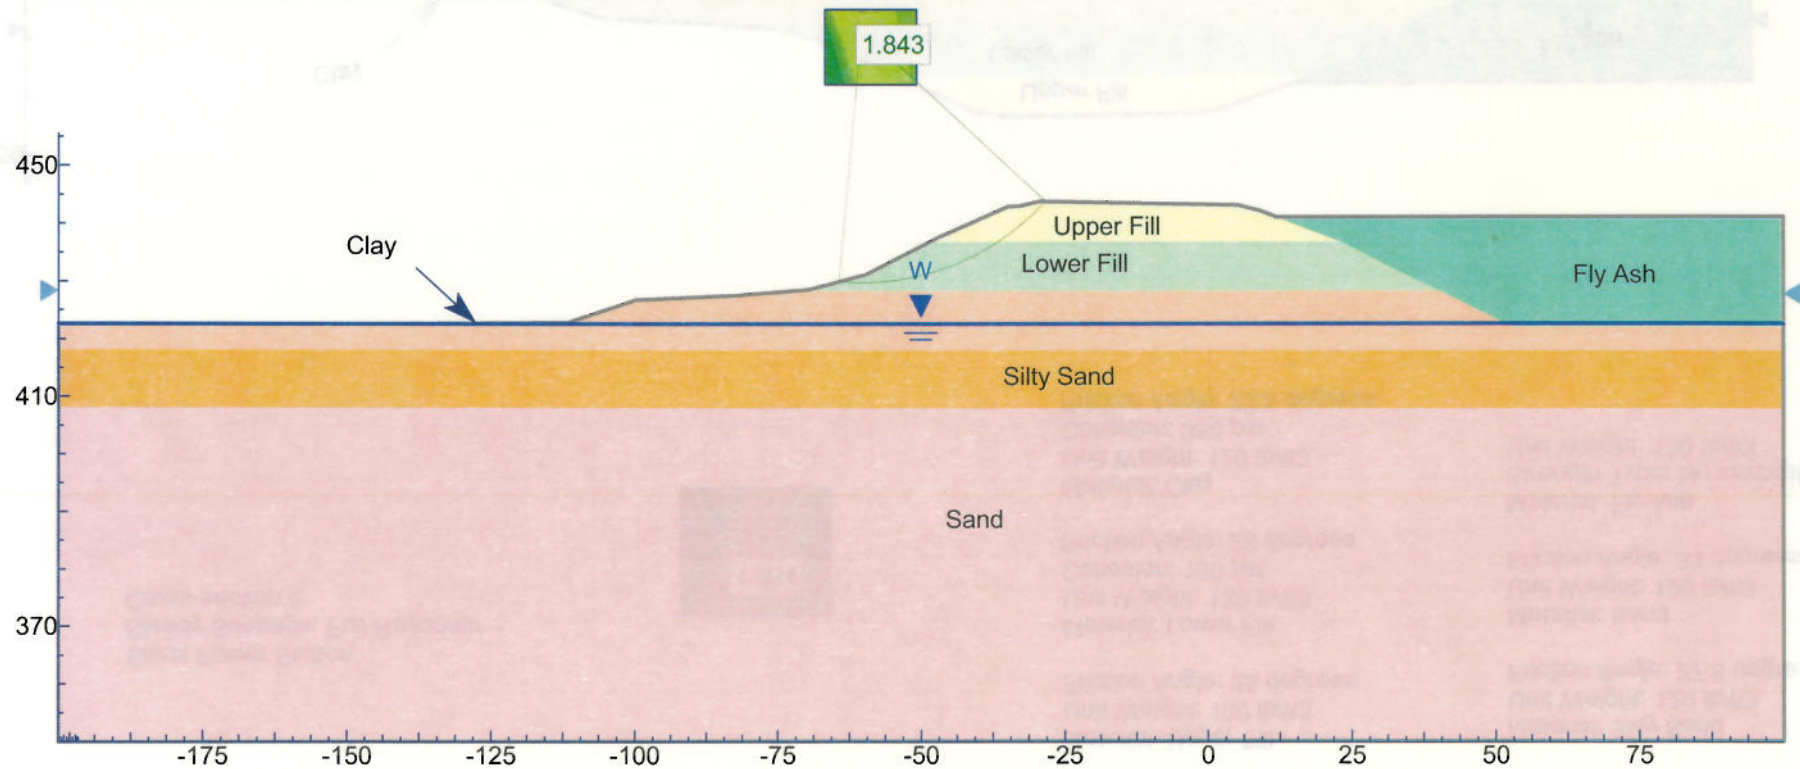
Sioux Power Station  
Seismic, Full Reservoir  
Cross-section 5

Material: Upper Fill  
Unit Weight: 120 lb/ft<sup>3</sup>  
Friction Angle: 25 degrees

Material: Clay  
Unit Weight: 120 lb/ft<sup>3</sup>  
Cohesion: 350 psf  
Friction Angle: 23.5 degrees

Material: Fly Ash  
Strength Type: No strength  
Unit Weight: 100 lb/ft<sup>3</sup>

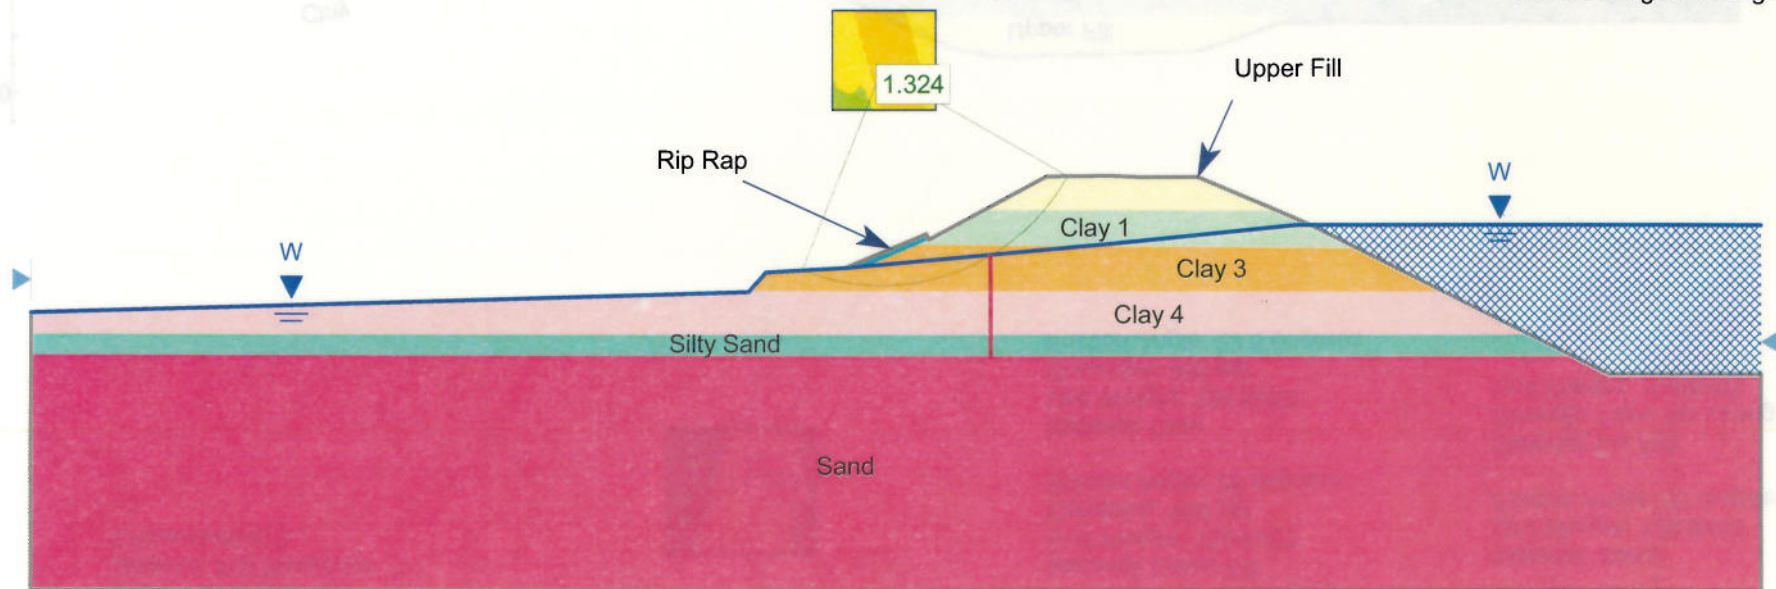
Sioux Power Station  
Seismic, Full Reservoir  
North Section

Material: Upper Fill  
Unit Weight: 120 lb/ft<sup>3</sup>  
Friction Angle: 27.5 degrees

Material: Sand  
Unit Weight: 120 lb/ft<sup>3</sup>  
Friction Angle: 35 degrees

Material: Rip Rap  
Unit Weight: 110 lb/ft<sup>3</sup>  
Friction Angle: 35 degrees
